SUBJECT: Animal Feeding Operation (AFO) Compliance Inspection for – Symens-Lowery Site 1,  
County – Franklin, – Facility #61699

## AFO INSPECTION REPORT

<b>FACILITY LOCATION</b>	Facility: <b>Symens-Lowery Site 1</b>			Facility ID#: <b>61699</b>	
	Address: <b>1555 Spruce Ave.</b>		City: <b>Hampton</b>	State: <b>IA</b>	Zip: <b>50441</b>
	PLSS: <b>Section 19, Ingham Township (T92N, R19W), Franklin County</b>				
<b>OWNER</b>	Name: <b>Symens - Lowery Inc.,</b>				
	Address: <b>Same</b>		City:	State:	Zip:
<b>ANIMAL HOUSING TYPE</b>	<input checked="" type="checkbox"/> Confinement <input type="checkbox"/> Open Lot <input type="checkbox"/> Combined (Confinement & Open Lot)				
<b>ANIMAL INFORMATION</b>	Animal Type(s)	Capacity	Current Head	Number of Bldgs./Pens	
	<b>Swine</b>	<b>4050-Head</b>	<b>4050</b>	<b>3 Buildings</b>	
	Date of Construction: <b>2001</b>		Date of Expansion: <b>2003 and 2004</b>

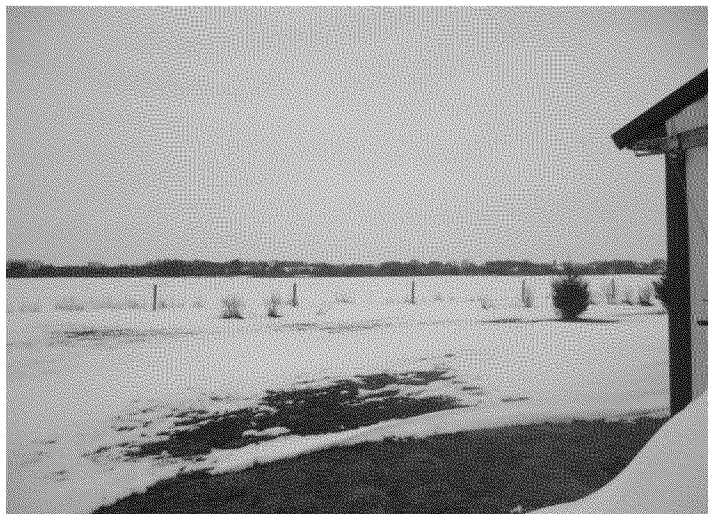
During my on-site inspection, I did not observe drainage tile surface intake(s) on-site or in the immediate vicinity of the facility. Site drainage appears to be possibly to the north, east or south; however, the surrounding topography is considerably flat and the nearest water source, Otter Creek, is located approximately 1200-feet to the north and approximately 2000-feet to the east. Consequently, unless unobserved tile intakes exist, the chance of site runoff resulting in a discharge of pollutants to Otter Creek appears unlikely.

Looking north toward Otter Creek (tree line in background) showing flat topography and distance between

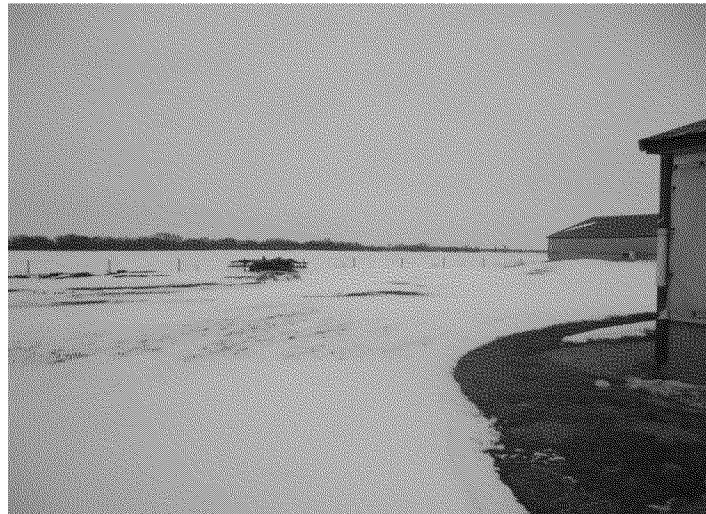
Looking east toward Otter Creek (tree line in background) showing flat topography and distance between

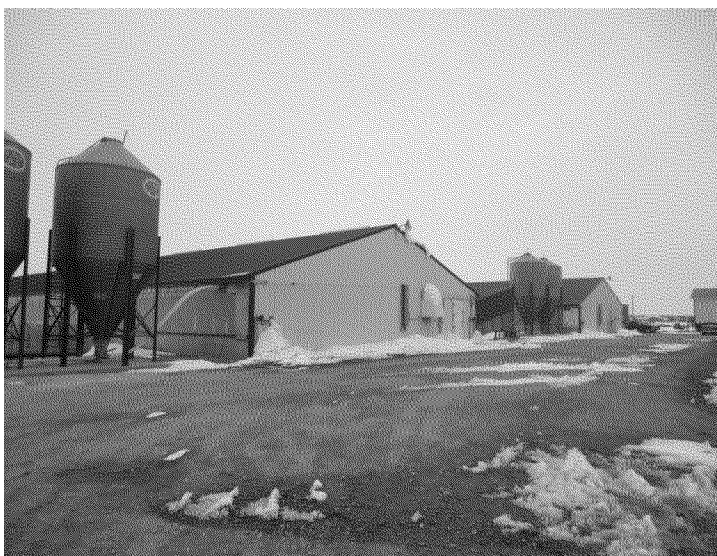
During the inspection, I observed the bulk bin feed system serving each building. All bins, feed conveyance pipes and various attachments appeared to be intact and effectively containing feed. However, I did observe evidence of a feed spill at one set of bins. Mr. Symens explained that he has had problems with feed delivery drivers spilling feed when filling the bins. It appeared that Mr. Symens had made an honest effort to clean-up the spilled feed, but there was, of course, some residual left in the gravel surrounding the bin pad. I cautioned Mr. Symens against allowing surface water runoff from the site to carry this residual feed to the creek; although that would be unlikely, as stated above. Still, this part of the operation should be inspected frequently, as runoff water could carry spilled feed into a water course where it could create violations of state water quality standards. Discharge of such process water would potentially require an NPDES permit.

West end of south two buildings – showing feed bins (spilled feed below bins at left in photo)

- 1) Regularly inspect wall-mount pit fans for leakage due to insufficient anchoring, aged caulking or other possible causes.
- 2) Impress upon feed delivery drivers and/or company personnel the need to exercise due caution when filling bins, as the discharge of feed-contaminated process water would potentially require and NPDES permit.
- 3) Ensure that rendering contractor can provide timely pick-up service or explore other appropriate carcass disposal options.

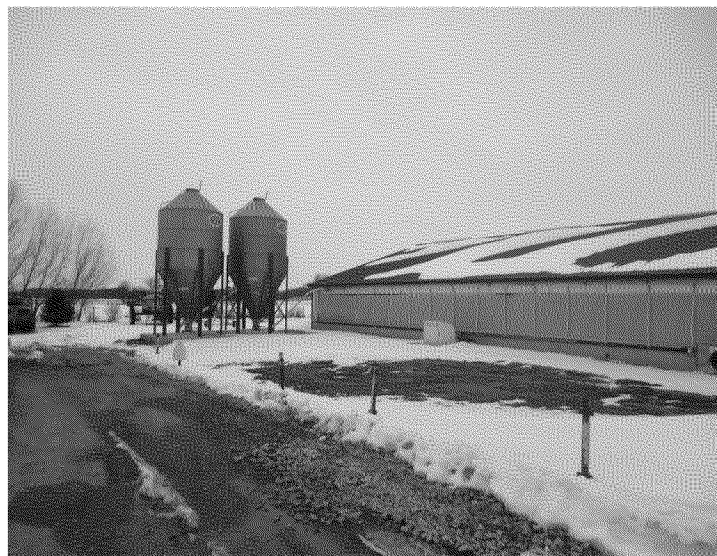
During the inspection, all three buildings were observed. I observed that portion of the concrete which was visible above-ground. This amounted to approximately 2-feet of concrete, which would be above the slats covering the below-building deep pits. The observed concrete appeared to be structurally sound and I did not observe any evidence of manure discharges from or in the vicinity of the building. I observed no evidence of cracking, excessive spalling or other issues of concern regarding the visible portion of the concrete. All three manure storage pits utilize a combination of pump-out pit fans and wall-mounted pit fans. The wall-mount pit fans were individually observed and no evidence of manure leakage at the transitions was observed. However, these transitions were shown to and discussed with Mr. Symens. I cautioned him to routinely inspect these fans for leakage due to insufficient anchoring, aged caulking or other possible causes.

West end of north building showing bins, pump-out pit fan (wall-mount pit fan in left edge of photo)

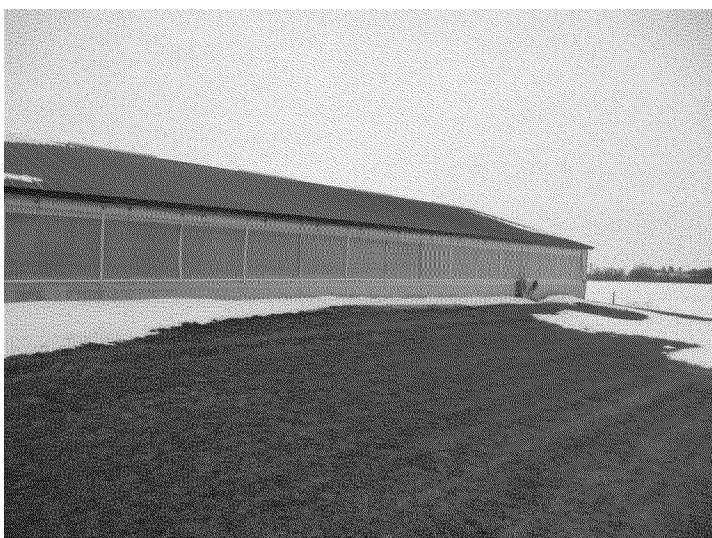
Representative photo of buildings with wall-mount pit fan

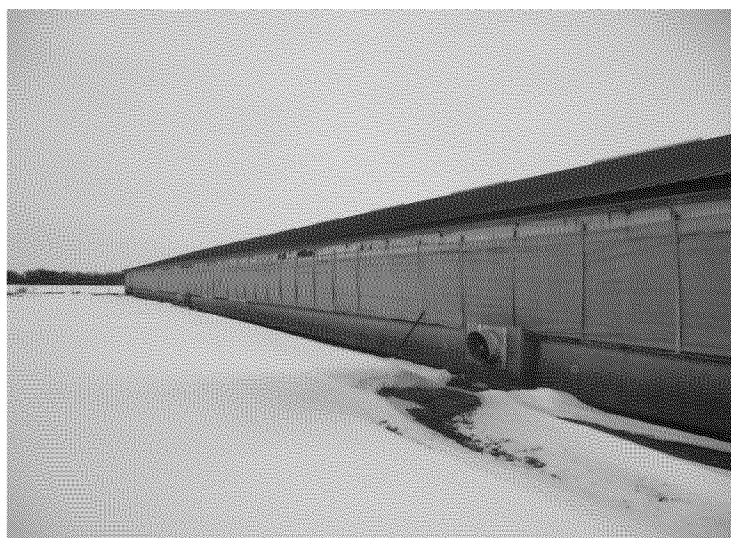
Close-up of wall-mount pit fan

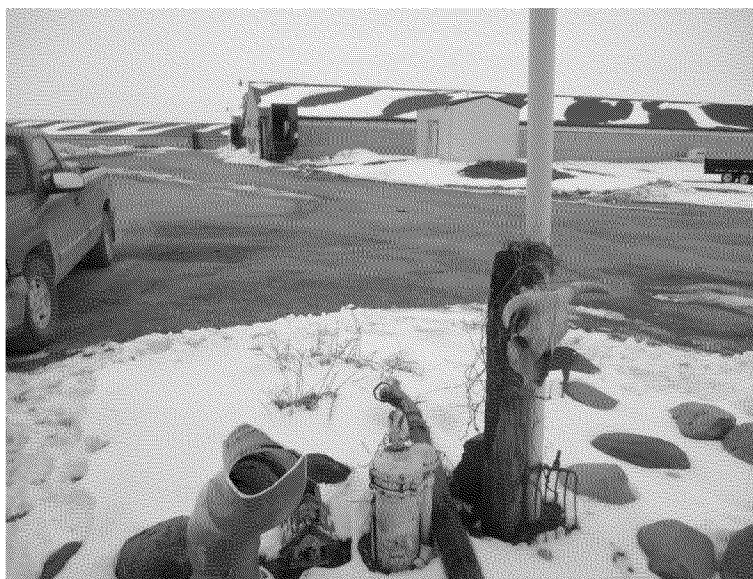
The water well serving this facility is located south of the confinement buildings. It is approximately 110-feet from the south-most (nearest) building. The area between the well and the buildings is significantly flat and while there is nothing which would make the well head particularly susceptible to contamination from a discharge, neither is there anything which would make the well head particularly protected from one either. Consequently, in the event of a manure release or spill at the facility, protection of the wellhead is paramount.

Looking north from well to buildings

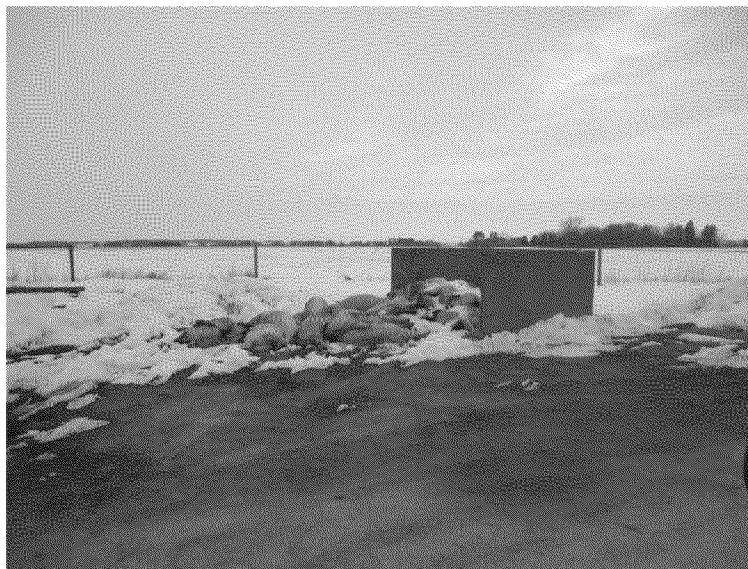
Carcasses were historically composted at this facility, but they are currently rendered on-site. The compost structure is located on the south edge of the facility next to the drive. The structure is concrete and is located on a packed-gravel, all-weather surface. The surrounding area is particularly flat and I observed no tile intakes in the area. Therefore, it appears to be in a good location with regard to the potential for surface runoff. At the time of the inspection, the structure was full of fat hogs, and there were approximately one-dozen carcasses piled on the gravel in front of the structure. Mr. Symens explained that he has a scheduled weekly renderer pick-up; however he recently contracted with a new rendering contractor and while they started-out well, he has had issues with timely pick-up lately. I suggested he contact the renderer and express the need to return to timely pick-up.
